Basic Imagery Interpretation Report

Major Electric Power Plants Szechwan Province, China

CENTRAL INTELLIGENCE AGENCY Directorate of Intelligence Imagery Analysis Service

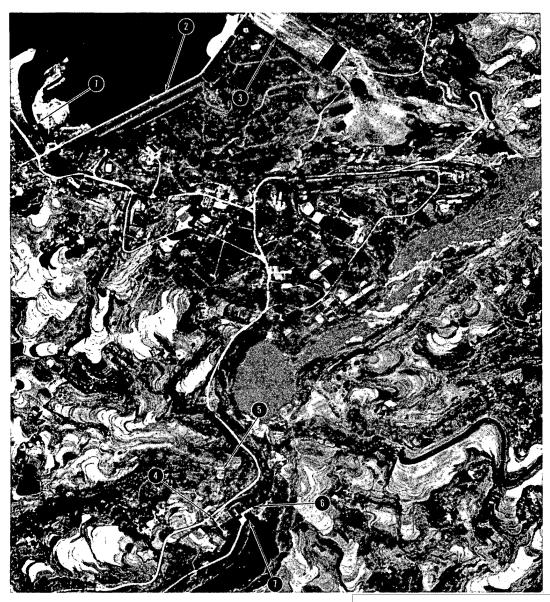
FIGURE 3. CHANG-SHOU HYDROPOWER PLANT SHIH-TZU-TAN

Key to Annotations
Item	Description
ı	Water Intake
2	Earthen Dam
3	Spillway
4	Switching Yard
5	Surge Tank
6	Powerhouse
7	Tailrace

The plant facilities include an earthen dam with a concrete spillway, a powerhouse, a switching yard, a surge tank and underground conduits. The water intake for the power plant is located at the west end of the dam. Four discharges at the base of the powerhouse indicate that it was designed to contain four turbogenerators. In June 1963 at least two and possibly three transformers were observed.

The powerhouse was complete when first observed on photography of June 1963. No changes have subsequently been observed on small scale photography through August 1969.

The powerhouse was operating in June 1963 and July 1965 when turbulence was observed in the tailrace. The small scale of the August 1968 and August 1969 photography precluded the observation of turbulence, but there was evidence that the plant was active. Although no water was observed coming down the spillway of the dam, water was flowing below the powerhouse. This water was probably coming through an underground conduit and the powerhouse.
